MISABID007 Stormwater Master Plan Draft Report

Prince Albert Local Municipality

December 2014

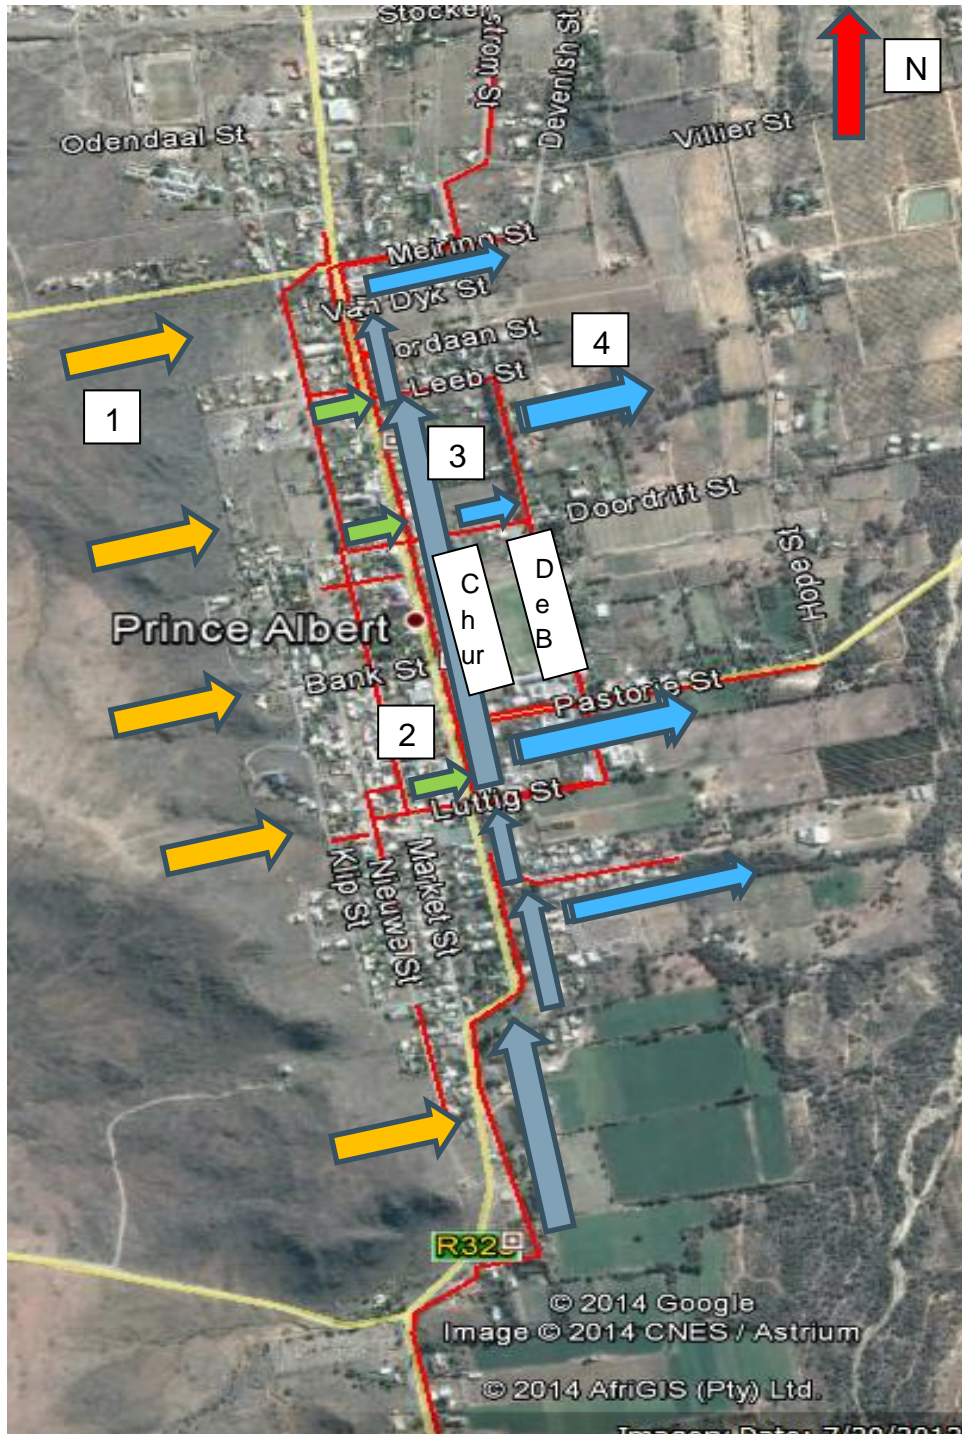
Map 4.1: Prince Albert South Existing Stormwater System and Drainage

PAS lies on the foot of a hilly region to the east of the town. The town uses overland flow and open channels to convey the stormwater. However, when there are high intensity storms the town experiences flash flooding. During the site visit the following issues attributing the stormwater problem were identified:

- Poor conditions, slopes and gradients of channels
- No clear stormwater system routing for minor and major flood events
- Poor drainage in open spaces between households
- Poor maintenance of existing stormwater infrastructure which cause blockages of inlets and outlets.

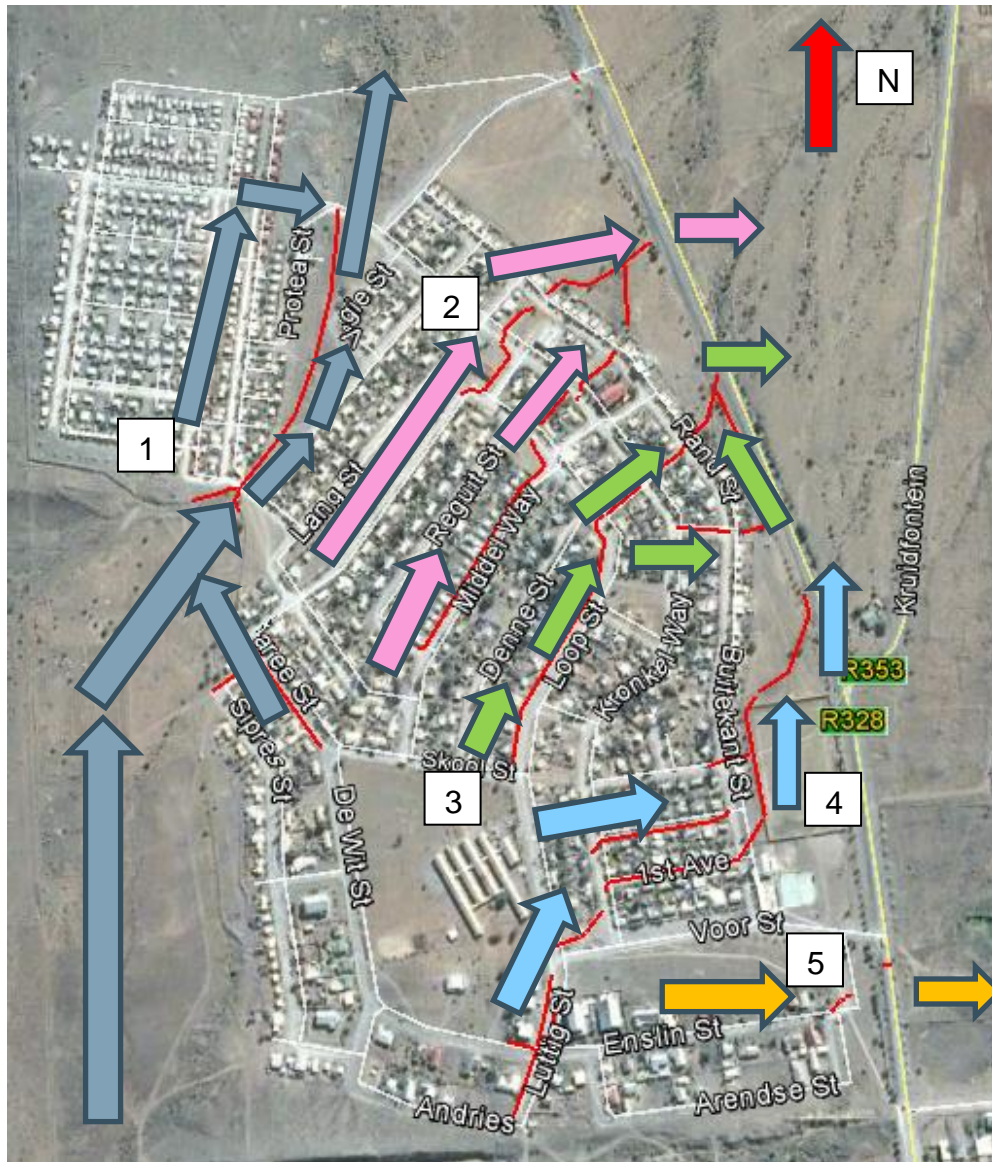
Map 4.2: Prince Albert North Existing Stormwater System and Drainage

During the site visit the following issues attributing the stormwater problem were identified:

- Poor conditions, slopes and gradients of channels
- Poor drainage in open spaces between households
- Poor maintenance of existing stormwater infrastructure which cause blockages of inlets and outlets.

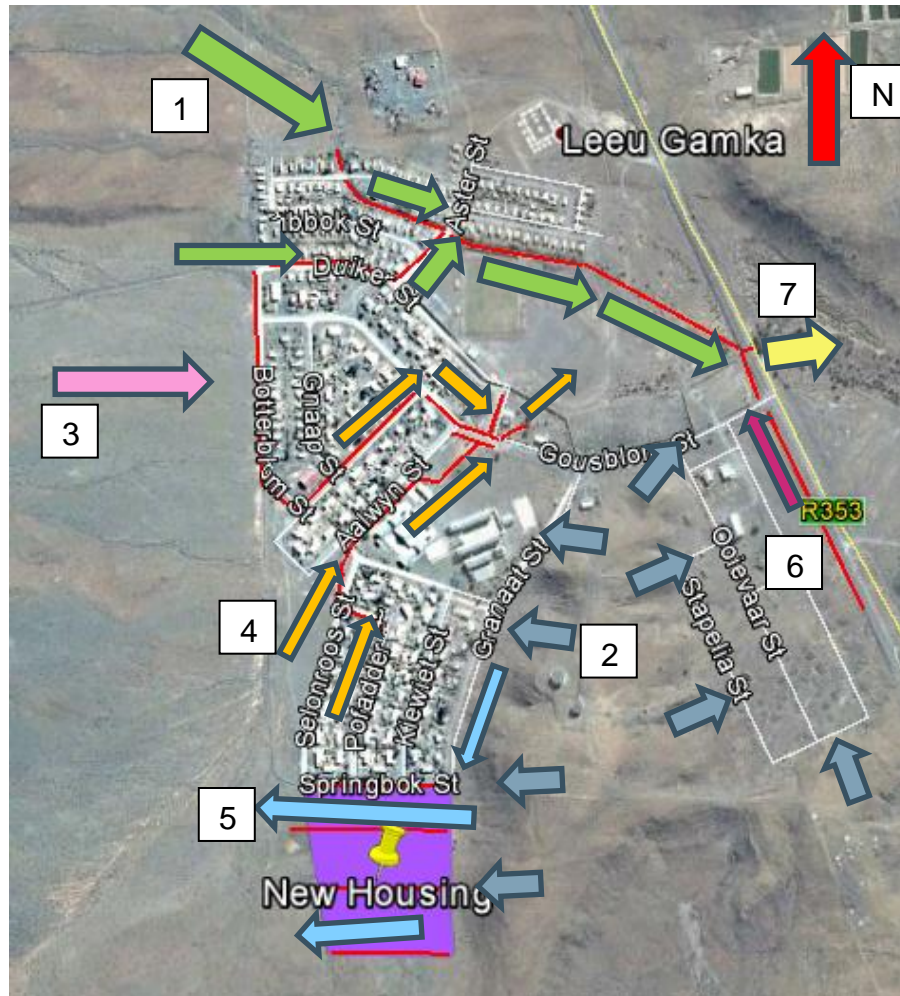
Map 4.3: Leeu Gamka Existing Stormwater System and Drainage Paths

During the site visit the following issues attributing the stormwater problem were identified:

- Poor conditions, slopes and gradients of channels
- Poor drainage in open spaces between households
- Poor maintenance of existing stormwater infrastructure which cause blockages of inlets and outlets.

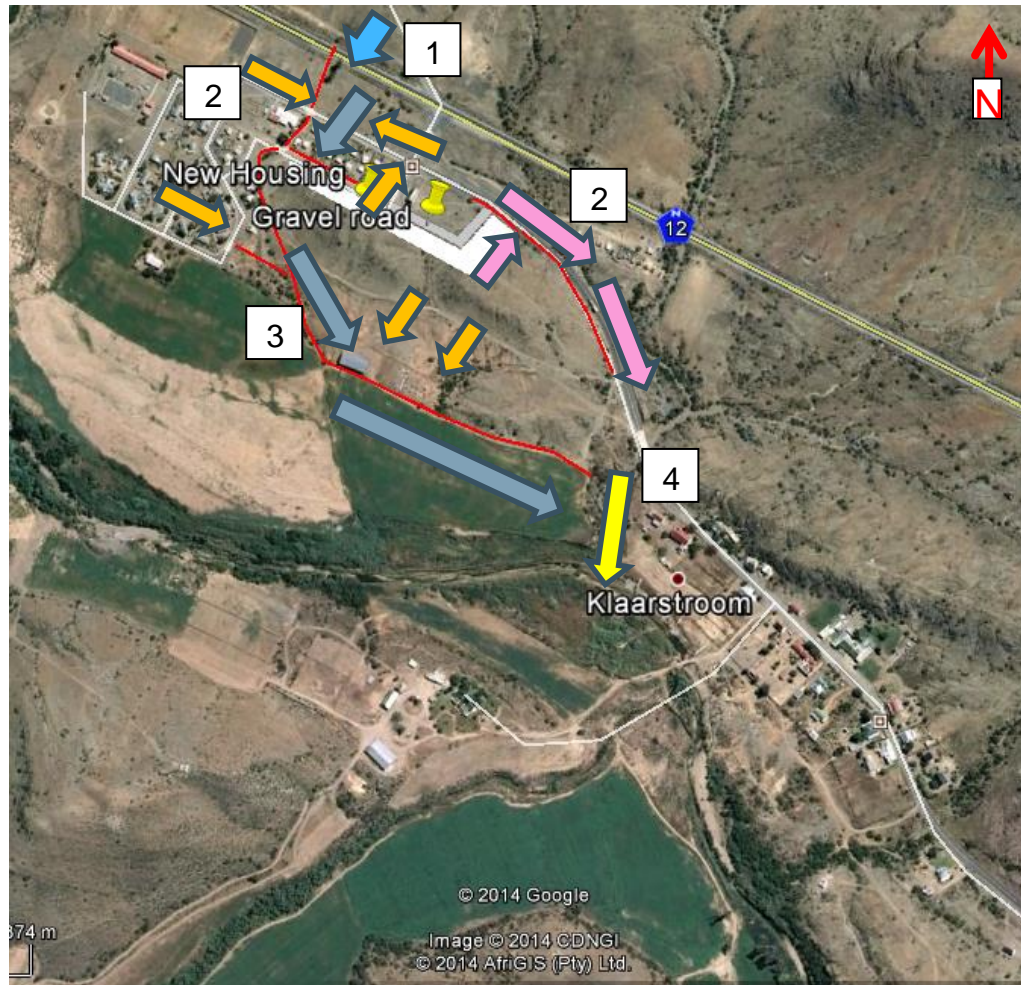
Map 4.4: Klaarstroom Existing Stormwater System and Drainage Paths

During the site visit the following issues attributing the stormwater problem were identified:

- Poor conditions, slopes and gradients of channels
- Poor drainage in open spaces between households
- Poor maintenance of existing stormwater infrastructure which cause blockages of inlets and outlets.

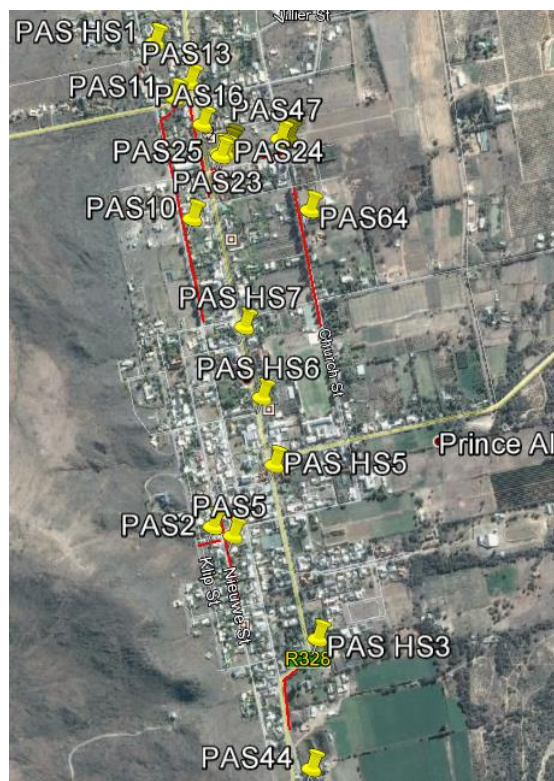
Figure 8.1: Map of Prince Albert South Historical Stormwater Issues

Name	Town	Street	Structure	Material	Comments
PAS2	Prince Albert	Klip - Nieuwe	Channel	Stone Pitched	Stone pitching worn away and partially covered in dense vegetation
PAS5	Prince Albert	Nieuwe	Channel	Concrete	Badly damaged. Crumbling and has poor slope and profile
PAS10	Prince Albert	Market	Channel	Cement	Partial vegetation and debris
PAS11	Prince Albert	Market - MagrietaPrinsloo	Channel	Grass	Dense vegetation
PAS13	Prince Albert	MagrietaPrinsloo	Culvert	Cement	Partially blocked by vegetation and debris
PAS16	Prince Albert	Church	Channel	Stone pitched /Unlined	Partially vegetated. Slope appears too flat too optimally
PAS23	Prince Albert	Jordaan and Church	Channel	Stone pitched	Greywater from prison flowing into system
PAS24	Prince Albert	Jordaan	Culvert	Concrete	Greywater from prison flowing into system
PAS25	Prince Albert	Jordaan	Channel	Concrete	Inlet blocked with vegetation
PAS26	Prince Albert	Jordaan	Detention Pond	Brick and Concrete	Inlet blocked with vegetation and vegetation growing in pond, concrete cracking

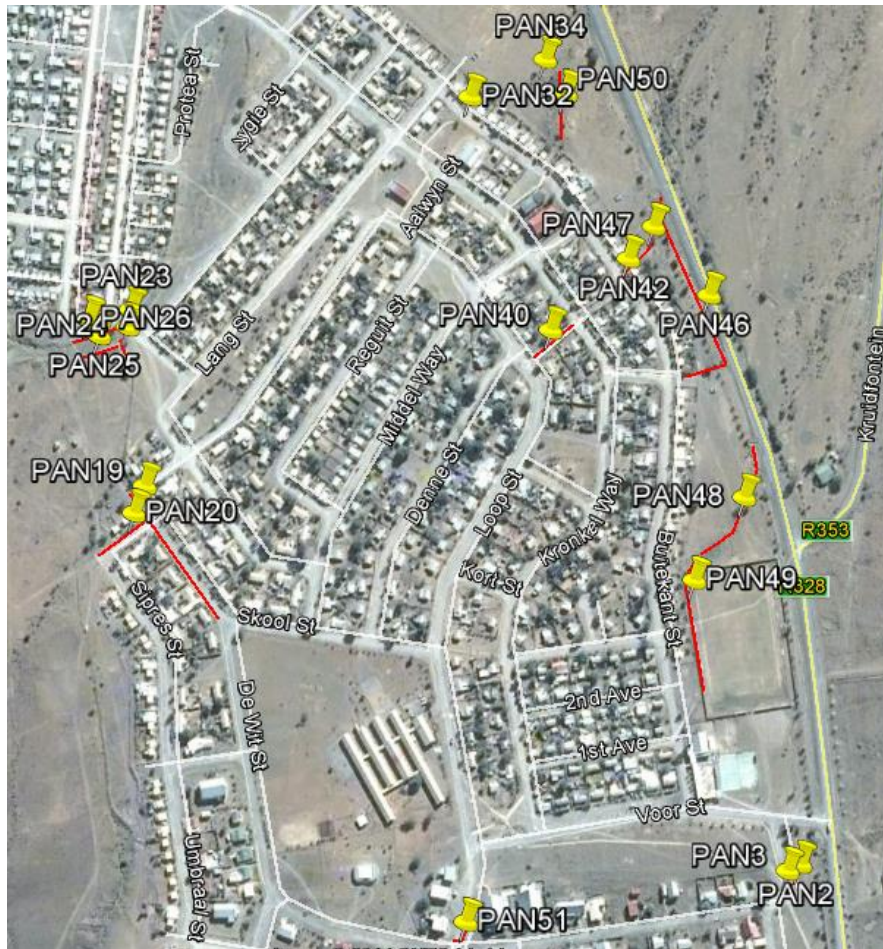
Figure 8.2: Map of Prince Albert North Historical Stormwater Issues

Conduit	Street	Structure	Material	Comments
PAN2	Enslin	Culvert	Concrete	Blocked with some rubbish and vegetation
PAN3	Enslin walkway	Culvert	Plastic	Blocked with some rubbish and vegetation
PAN19	Karee	Channel	Concrete	Blocked by house driveways and debris. Slope too flat
PAN20	Spires and Karee	Channel	Concrete	Drains into an unlined informal channel
PAN23	Botterblom	Culvert	Concrete	Partially full with debris. Appears to be an illegal dumping hot spot.
PAN24	Botterblom	Gabion	Rocks and cement	Gabion slightly worn. Rocks missing
PAN25	Botterblom	Gabion	Rocks and cement	Gabion slightly worn. Rocks missing
PAN26	Botterblom	Gabion	Rocks and cement	Gabion slightly worn. Rocks missing
PAN32	Rand	Culvert	Concrete	Partially blocked with debris, rubbish and vegetation
PAN34	Rand to R328	Channel	Unlined	Unmaintained
PAN40	Loop- KronkelWeg	Channel	Concrete	Silted up
PAN42	Rand	Road Crossing	Concrete	Blocked with debris and vegetation

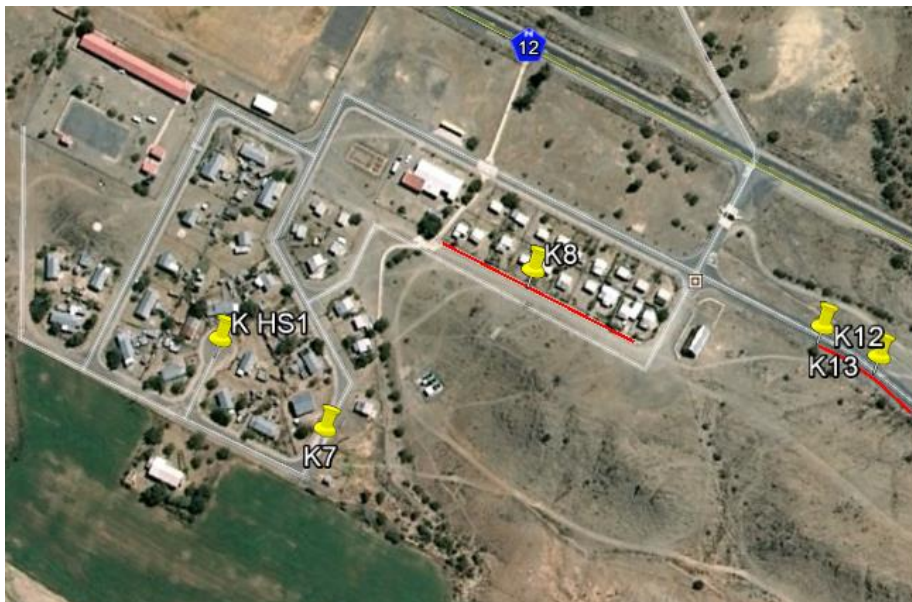
Figure 8.4: Map of Klaarstroom Historical Stormwater Issues

Conduit	Street	Structure	Material	Comments
C3	Klaarstroom	Channel	Unlined	Dense vegetation which could cause ponding upstream
K8	Aalwyn	Channel	Concrete	Slope very flat water stands. Does not stop water from flowing into houses downstream
K12	Unknown and R407	Culvert	Concrete	Some rubbish blocking inlet
K13	R 407	Channel	Stone pitched and unlined	Poor condition

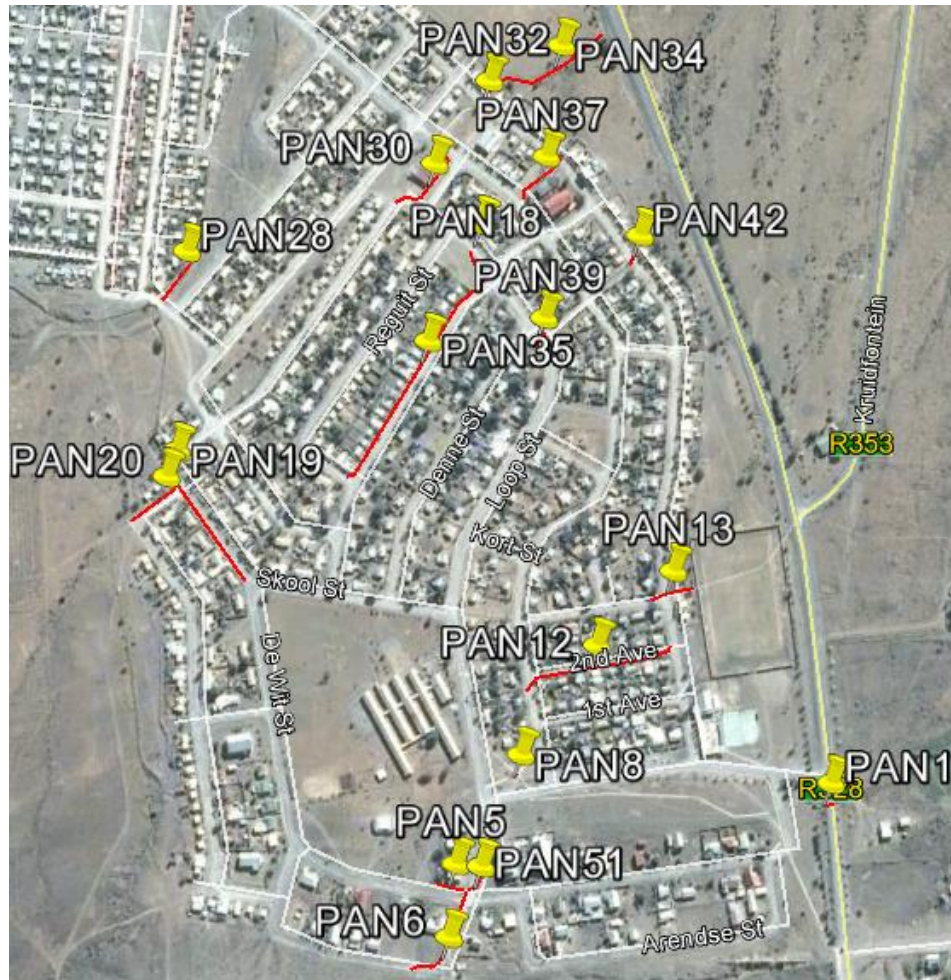
Figure 8.6: Identified Stormwater Analysis Issues in Prince Albert North

Prince Albert North has a lot of issues because of supercritical flowing stormwater. The channels are often too shallow and have sharp direction changes and therefore water just continues on its initial flow path into properties and onto the roads (Buitekant and KronkelWeg). The stormwater issues identified in the analysis are listed in Table 8.6 and shown in Figure 8.6.

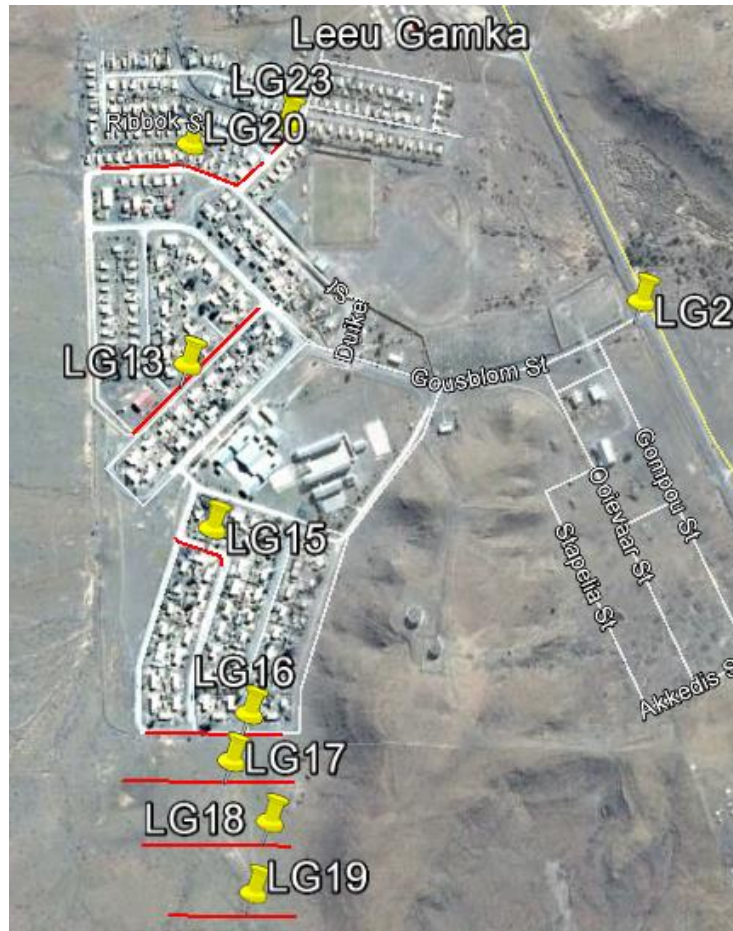
Figure 8.7: Identified Stormwater Analysis Issues in Leeu Gamka

Leeu Gamka’s main stormwater problems are the culverts in Aster Street. Other issues include supercritical flow from the channels in the new housing development portion of the Leeu Gamka. The stormwater issues identified in the analysis are listed in Table 8.7 and shown in Figure 8.7.

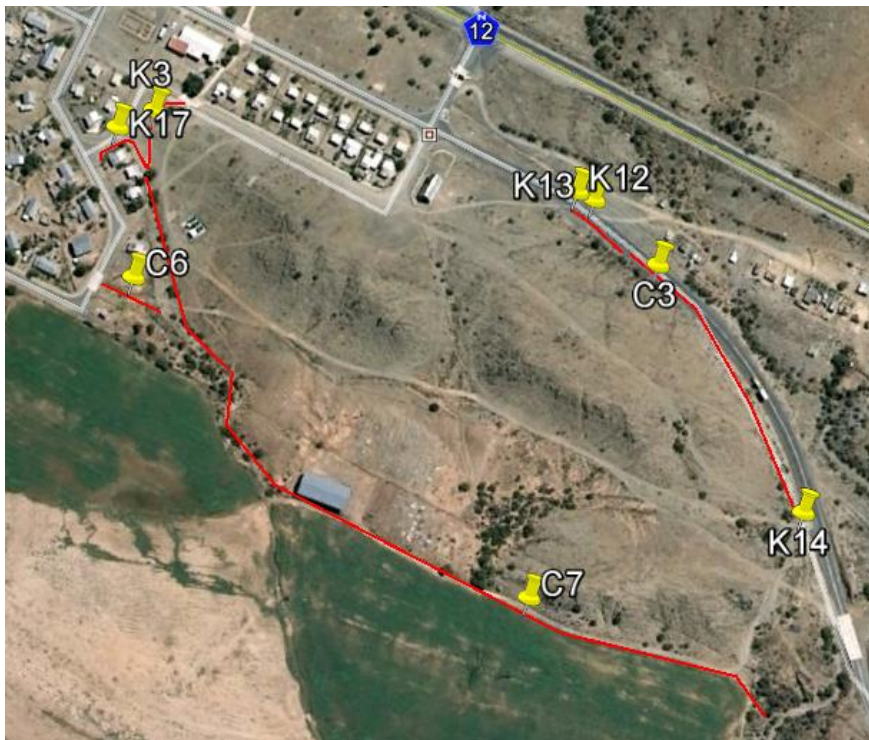
Figure 8.8: Identified Stormwater Analysis Issues in Klaarstroom

Klaarstroom does not have sufficient capacity to convey stormwater away from the settlement (K17 and C3). In addition some local flooding occurs due to supercritical flow – stormwater flows past K8 on Aalwyn Street into properties on other side of street. The stormwater issues identified in the analysis are listed in Table 8.8 and shown in Figure 8.8.
