# MISABID007 Stormwater Master Plan Draft Report

Prince Albert Local Municipality

December 2014

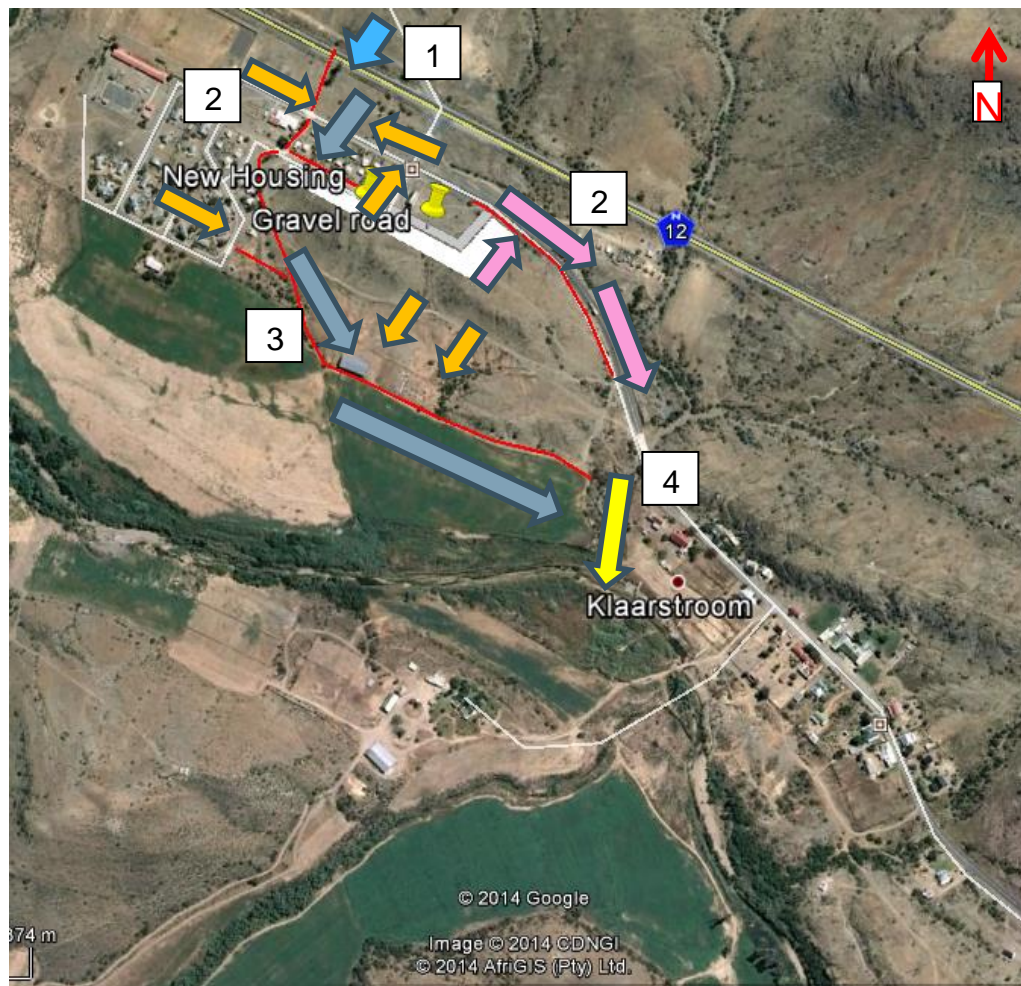
Map 4.4: Klaarstroom Existing Stormwater System and Drainage Paths

1. Stormwater from hills across the N12 (light blue) drains south through a culvert and then into a stormwater channel in Klaarstroom (dark blue).
2. Stormwater from hills in Klaarstroom flows towards the R407 to the North (pink) and stormwater from the southern side of the hill drains towards a natural channel to the south (orange).
3. Stormwater from Klaarstroom (orange) flows into a series of channels and low level road crossing which joins the natural stormwater channel (dark blue).
4. Stormwater from the R407 drains towards a low level bridge crossing (yellow) which drains towards the river.

During the site visit the following issues attributing the stormwater problem were identified:

- Poor conditions, slopes and gradients of channels
- Poor drainage in open spaces between households
- Poor maintenance of existing stormwater infrastructure which cause blockages of inlets and outlets.

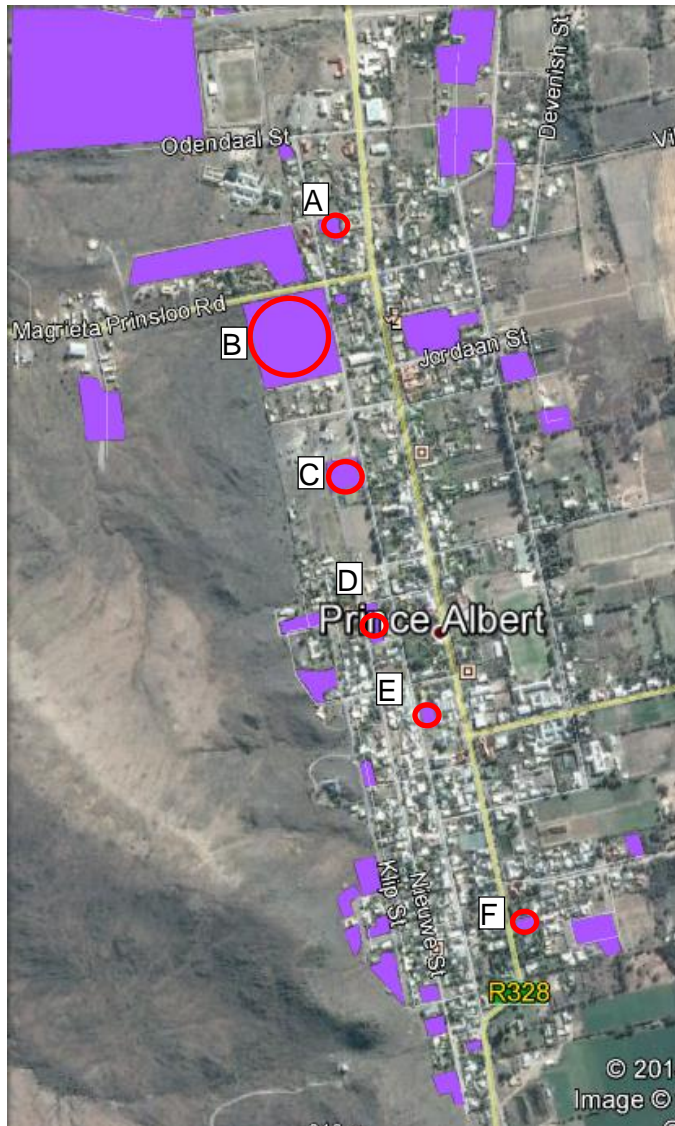
Figure 7.5: Candidate Sites for Stormwater Detention Ponds in Prince Albert South

The best areas for detention ponds (circled in red) in Prince Albert South are the areas designated for future residential development (purple), especially those located to the west of Church Street. The location of the most suitable detention pond will be subject to land zoning and geotechnical studies on the identified sites. Six areas have been identified for detention ponds. Ponds A to E will reduce the flow into Church Street from the hills to the west of the town. Pond F will serve as a buffer for stormwater flowing from the south along the R328 and could be discharged to the farmlands to the east.

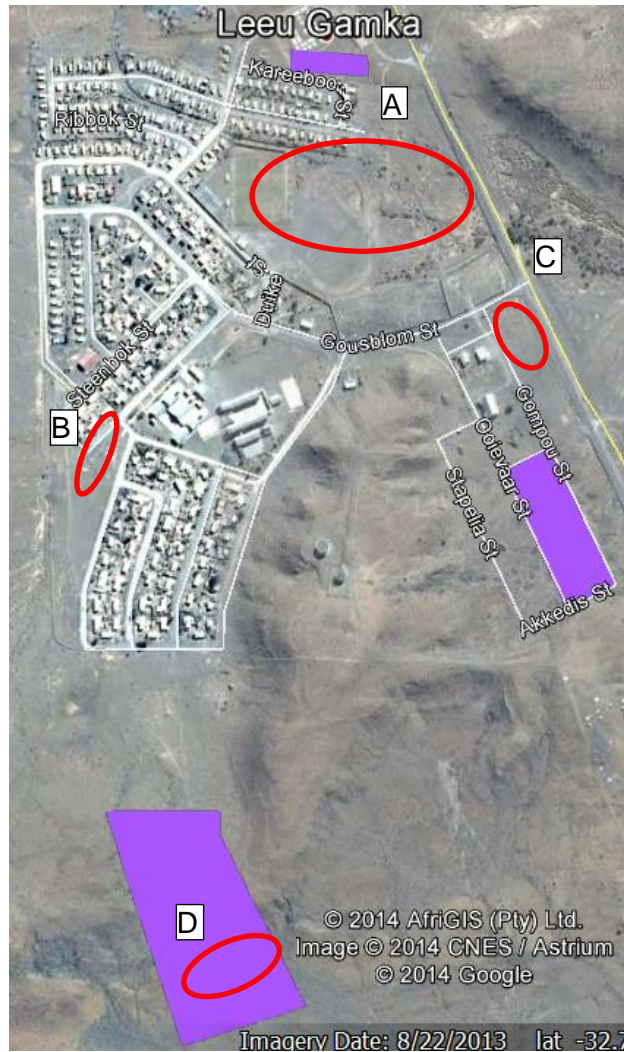
Figure 7.7: Candidate Sites for Stormwater Detention Ponds in Leeu Gamka

The best areas for detention ponds in Leeu Gamka are circled in red. The location of the most suitable detention pond will be subject to land zoning and geotechnical studies on the identified sites. Four possible areas have been identified for detention ponds. The playground at the bottom of Pofadder Street (Pond B) can be used to retain stormwater from the streets to the west, Pond C can receive stormwater from the community hall and future developments, Pond A will serve as the majority of the stormwater discharge from Leeu Gamka and the gabion channel and Pond D may serve the new housing developments to the south depending on the development design.

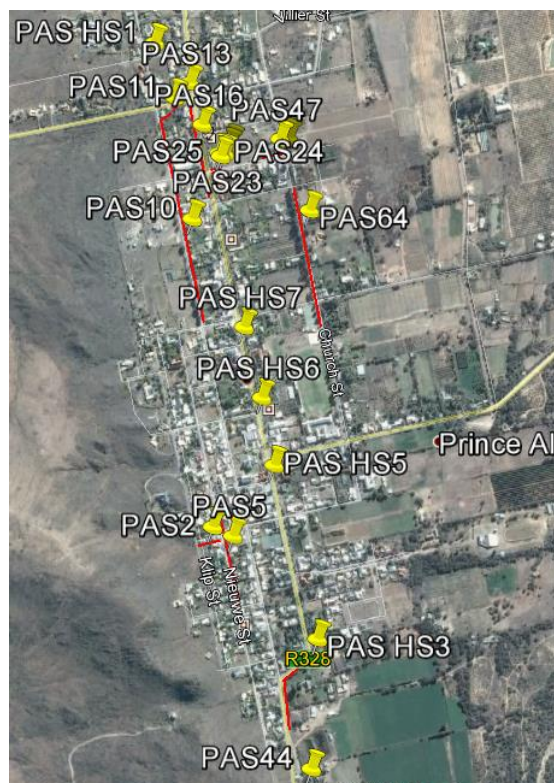
Figure 8.1: Map of Prince Albert South Historical Stormwater Issues

The stormwater issues identified in Prince Albert South are listed and described in Table 8.1 and are shown in Figure 8.1.

Name	Town	Street	Structure	Material	Comments
PAS HS1	Prince Albert	Corner of Market Street and one street past MargrietPrinsloo			Ponding or flooding of stormwater onto properties
PAS HS2	Prince Albert	Corner of Odendaal Street and Market Street	Stormwater Channel	Earth	Stormwater channel flows through housing property
PAS HS3	Prince Albert	Corner of R328 (Gay's Dairy)			Stormwater flows into property
PAS HS4	Prince Albert	Parsonage Street into Church Street			Stormwater flows into street and has potential to pond
PAS HS5	Prince Albert	Bank Street into Church Street			Stormwater flows into street and has potential to pond
PAS HS6	Prince Albert	Chaplin Street into Church Street			Stormwater flows into street and has potential to pond

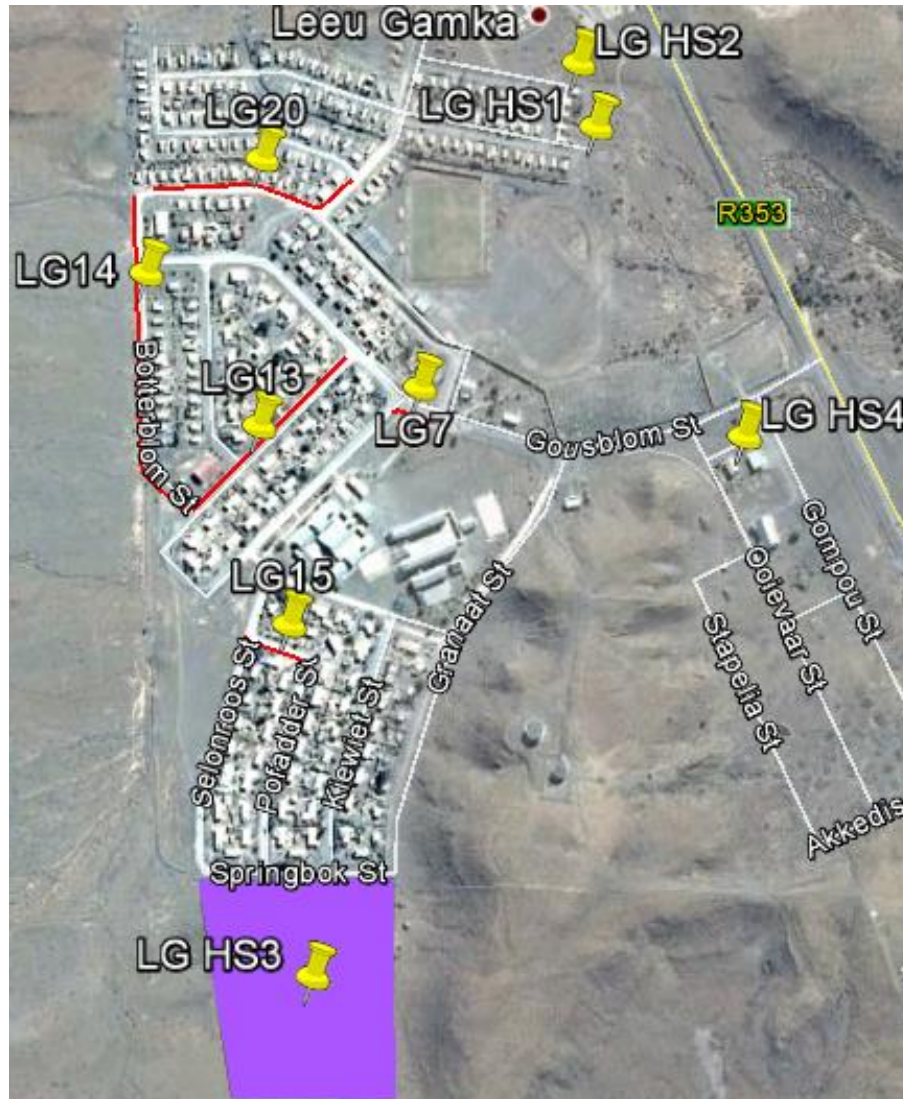
Figure 8.3: Map of Leeu Gamka Historical Stormwater Issues

The stormwater issues identified in Leeu Gamka are listed and described in Table 8.3 and are shown in Figure 8.3.

Conduit	Town	Street	Component 1	Material	Comment
LG13	Leeu Gamka	Steenbok	Channel	Concrete	Low point at Vygie, very flat
LG14	Leeu Gamka	Botterblom	Channel	Concrete	Low point at Botterblom and Steenbok and Low point at Gousblom and Botterblom
LG15	Leeu Gamka	Poffader	Channel	Concrete	Low point near top, drains backwards
LG20	Leeu Gamka	Duiker - Aster	Channel	Concrete	Depth varies from 0.15 at start to 1m at culvert LG20

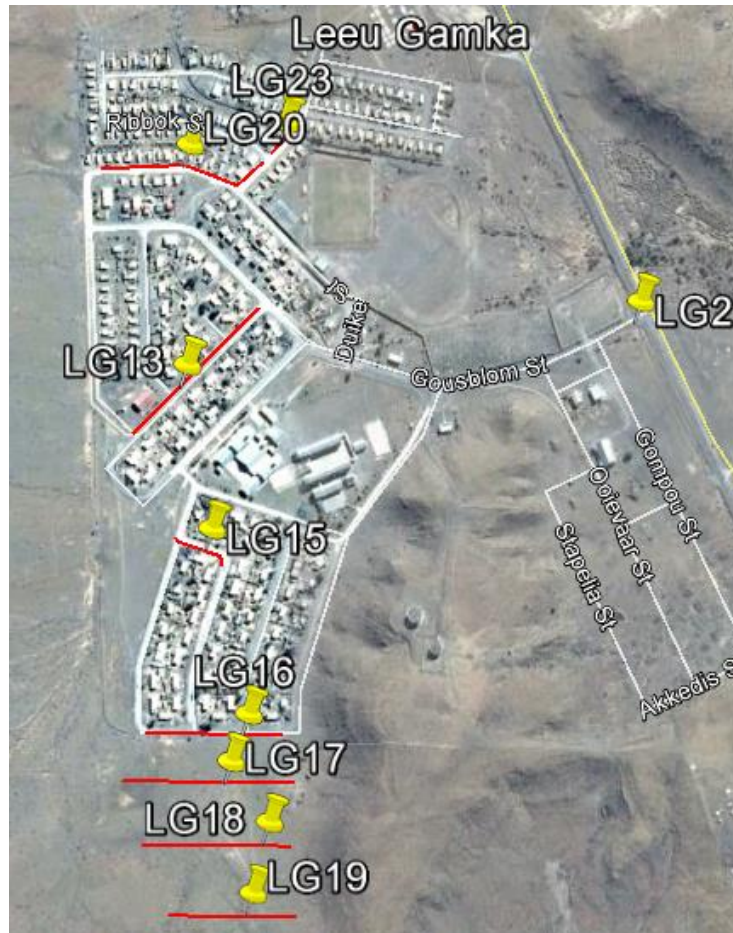
Figure 8.7: Identified Stormwater Analysis Issues in Leeu Gamka

Leeu Gamka’s main stormwater problems are the culverts in Aster Street. Other issues include supercritical flow from the channels in the new housing development portion of the Leeu Gamka. The stormwater issues identified in the analysis are listed in Table 8.7 and shown in Figure 8.7.

Conduit	Velocity	Super Critical	Flooding/ Capacity
LG20		Yes	Yes
LG13		Yes	
LG15		Yes	
LG16	Yes	Yes	
LG17	Yes	Yes	
LG18	Yes	Yes	
LG19		Yes

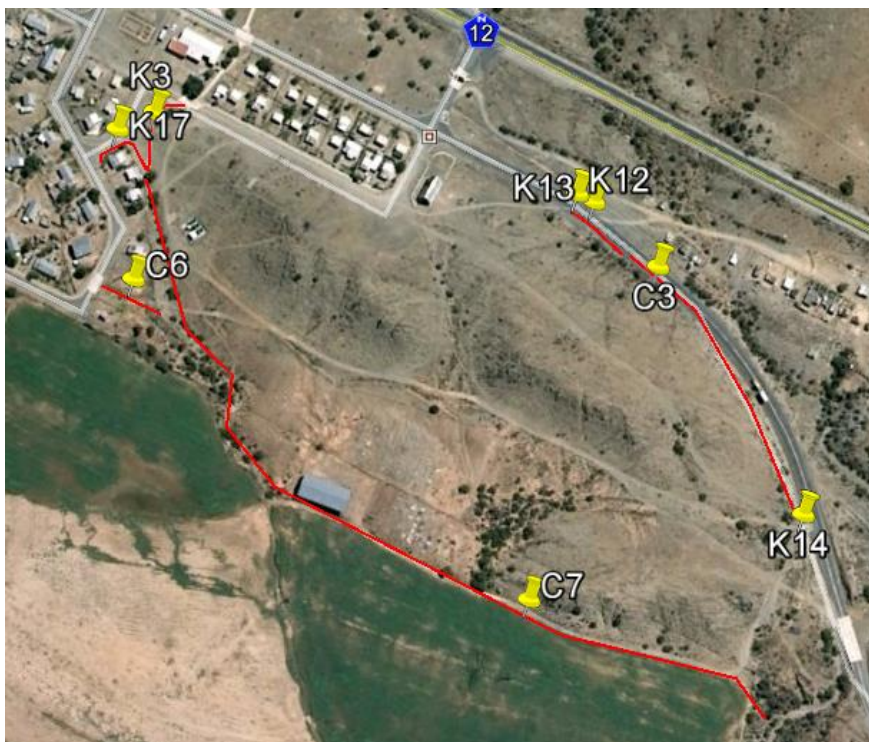
Figure 8.8: Identified Stormwater Analysis Issues in Klaarstroom

Klaarstroom does not have sufficient capacity to convey stormwater away from the settlement (K17 and C3). In addition some local flooding occurs due to supercritical flow – stormwater flows past K8 on Aalwyn Street into properties on other side of street. The stormwater issues identified in the analysis are listed in Table 8.8 and shown in Figure 8.8.

Conduit	Velocity	Super Critical	Flooding/Capacity
C6	Yes		
K14	Yes		
C3			Yes
K17			Yes
